THESIS

DETERMINATION OF THE DUCTILE TO BRITTLE
TRANSITION TEMPERATURE OF
PLATINUM-ALUMINIDE GAS
TURBINE BLADE COATINGS

David J. Vogel

September 1985

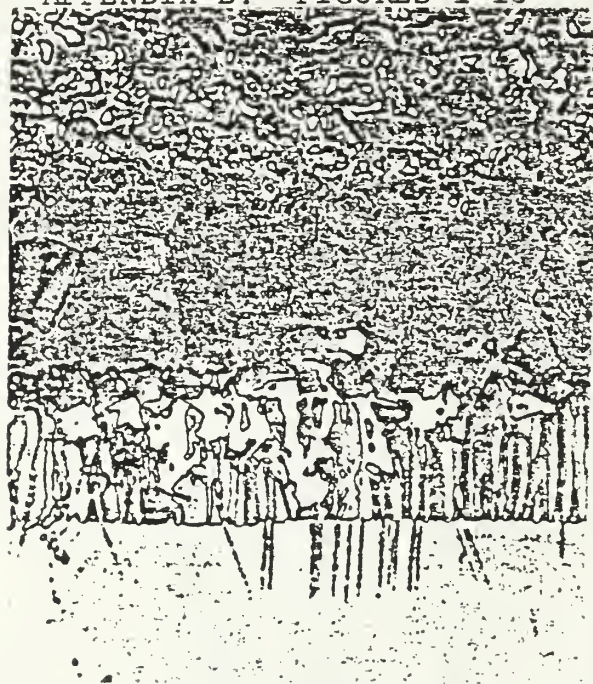
Figure 1. Inward Nickel-Aluminide Coating (1000x)

forms. Alternatively, if a relatively high formation temperature with a low aluminum activity is chosen, an "outward" nickel diffusion will occur in the $\beta(\text{NiAl})$ and a two zone structure will result showing a nickel-rich $\beta(\text{NiAl})$ phase on the outside with a $\beta(\text{NiAl})$ /substrate phase mixture next to the substrate. Inward and outward aluminide coatings are shown in Figures 1 and 2.

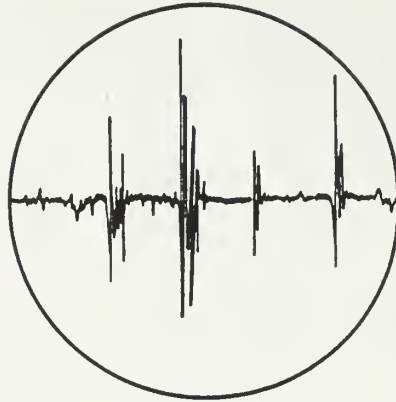
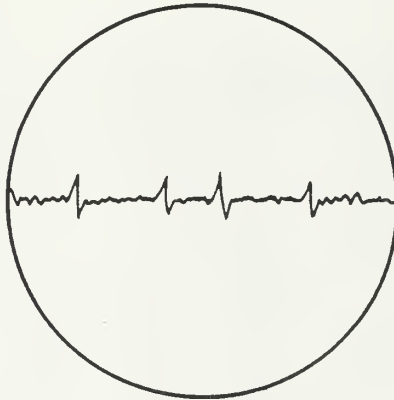
STRAINING EMBRITTLED SUBSTRATE

EXHIBITS COATING CRACKING

THERMAL EXPANSION AND INSTRON MACHINE NOISE

Figure 10. Typical Oscilloscope Signatures During Tensile Testing

Once several specimens were tested, it became very clear what the signature of a coating crack looked like on the

oscilloscope (see Figure 10b). Whenever this sharply defined characteristic was exhibited on the oscilloscope, there were cracks which could be observed on the specimen gage length at 425x under an optical microscope, and whenever this signature did not appear there were no cracks, regardless of how much strain the specimen had undergone and no matter what other patterns appeared on the oscilloscope. This is considered reasonable proof that the oscilloscope signature shown in Figure 10b was coating cracking observed during tensile straining of the specimens. Further confirmation of the cracking signature was provided by testing done above 800°C. The specimens deformed very quietly at these temperatures, they registered minimal noise on the oscilloscope, and so the cracking signature was even more distinguishable than at lower test temperatures where other noise was present on the scope. For instance, the test of coating No. 2 specimen No. 1 conducted at 860°C showed practically a clear scope, even though it was strained to 1.71%. Optical microscopy revealed no cracking of the specimen. Coating No. 3 specimen No. 1 on the other hand, which was also tested above 800°C, displayed the distinctive signature shown in Figure 10b beginning at 0.25% strain and continuing until approximately 0.65% strain with a clear scope showing beyond that point until the specimens fractured at 2.20% strain. Examination of this specimen
